EVALUATION OF ASPHALT PAVEMENT CRACK SEALING

Kelly Carrick
McAsphalt Industries Limited
Toronto, Ontario

John Emery and Ludomir Uzarowski
John Emery Geotechnical Engineering Limited
Toronto, Ontario

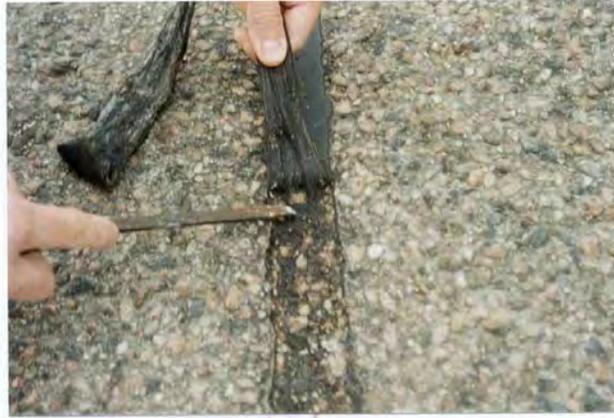
Crack sealing was carried out on Highway 11 south of Orillia in the summer of 1998 during good weather. There was no apparent problems with the crack sealant product or its installation at the time of construction. The pavement cracks were routed to the specified configuration (40 by 10 mm) and the rout was conditioned with hot, compressed air. The crack sealant was then applied. Some loss of the sealant from the routed cracks was reported shortly after a period of rain in the fall of 1998. A further significant quantity of sealant came out over the subsequent first winter period. A site inspection completed in 1999 indicated that red meta-arkose/granitic aggregate was used as the coarse aggregate in the surface course asphalt mix. The crack sealing material was found to be bonded only to the asphalt concrete in the top 2 to 3 mm at the edge of the rout and to the fine aggregate matrix between the coarse aggregates in the bottom of the rout, as indicated in Figure 1.

Figure 1. Crack Sealant Debonding on Highway 11, Southbound, Oro Road to Orillia, Summer 1999

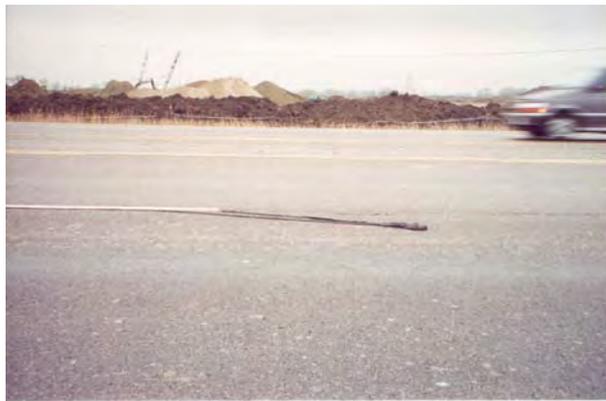
The asphalt pavement on Highway 50 in the Region of Peel incorporated a similar type of red meta-arkose coarse aggregate. A very significant loss of crack sealant installed in 2000 was reported in 2001. In some areas, losses as high as 70 to 90 percent were observed. Strips of crack sealant that had pulled out of the cracks were observed on the pavement surface, as indicated in Figure 2 and on the shoulders.

Figure 2. Failing Crack Sealant on Highway 50, Region of Peel, 2001

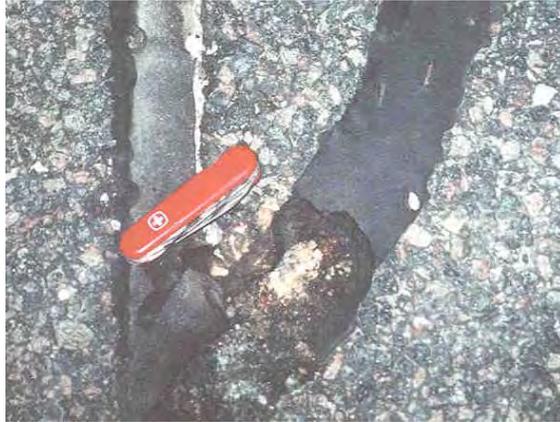
Hot-poured rubberized crack sealant was used on an Ontario Ministry of Transportation (MTO) Central Region crack sealing contract on Highway 401 Westbound through Mississauga (between Mississauga Road and Winston Churchill Boulevard) in the summer of 2000. The pavement cracks were routed to the specified configuration (approximately 40 by 10 mm) and the rout was conditioned with a hot pulse jet type lance. Crack sealant material was then installed in conformance with the project specification requirements. Some loss of sealant from the routed longitudinal grooves was first reported in the fall of 2000 after a period of cold, wet weather. A significant loss of sealant was also reported in the spring of 2001. Very poor bond was observed between the remaining crack sealant and the asphalt concrete pavement, as indicated in Figure 3. Note the shattered aggregate particles at the bottom of the rout where the sealant was removed. The sealant was bonded only to the top edges of the rout and to the asphalt concrete fine aggregate/asphalt cement matrix between the coarse aggregate.

Figure 3. Sealed Longitudinal cracks on Highway 401, Westbound in Mississauga

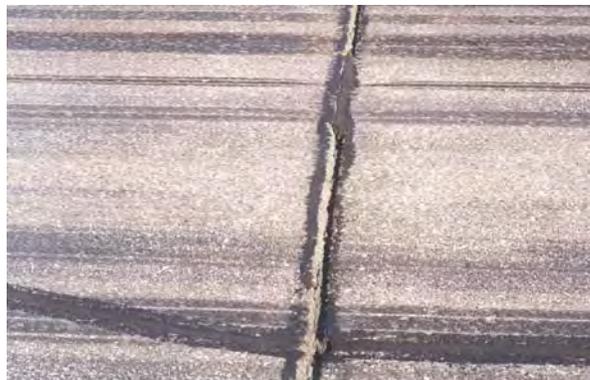
It was observed during the spring of 2000 that the pavement crack sealant from the previous summer's contract was becoming dislodged within the touchdown area of Runway 08-26, as indicated in Figures 4 and 5. It was observed (Figure 5) that particles of shattered aggregate had stuck to the bottom of the sealant giving it a sandpaper like texture.

Examination of the Runway 08-26 crack sealing revealed that most of the missing sealant was within the area at both ends of the runway where aircraft were landing (tire rubber marks on the pavement). The bond of the sealant was poor throughout these areas (except at the west end of the runway where the sealant was found to be well adhered).

Figure 4. Crack Sealant Debonded in Transverse Crack on Runway 08-26 at Canadian Forces Base Goose Bay

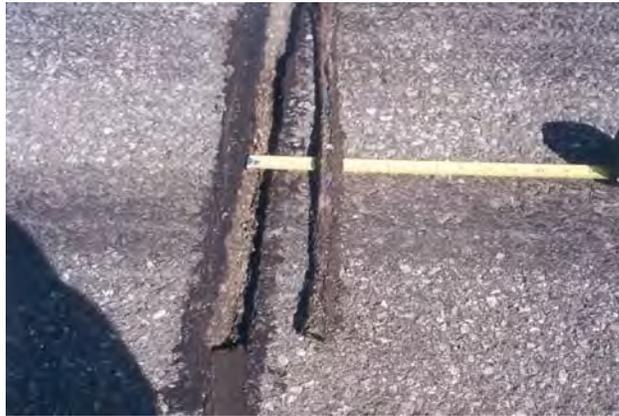
Figure 5. Debonded Crack Sealant in a Transverse Crack on Runway 08-26 at Canadian Forces Base Goose Bay

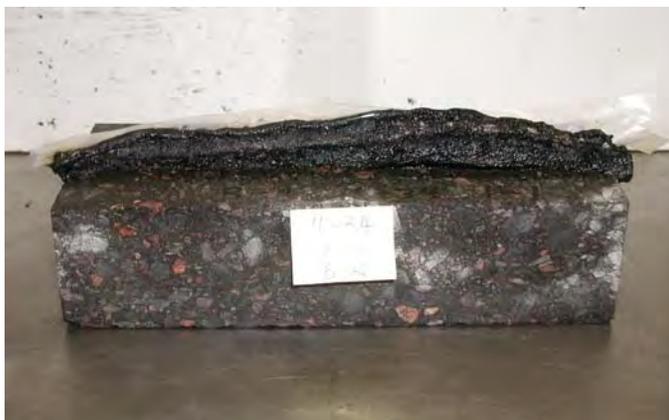
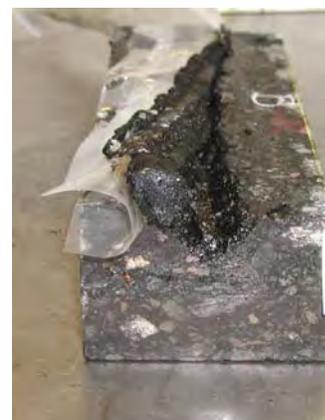
The results of the Stage 2 testing are summarized in Table 1. Figure 10 shows a sample with a routed reservoir that exhibited a failure after only 2000 cycles. The sealant was observed to be fully debonded from the asphalt concrete in the reservoir. Figure 11 shows a sample with a saw-cut reservoir that exhibited only partial failure after 8000 cycles. There was still some bond between the sealant and the asphalt concrete in the reservoir.

Figure 10. Sealant Debonded from Routed Reservoir after 2000 cycles in the Asphalt Pavement Analyzer

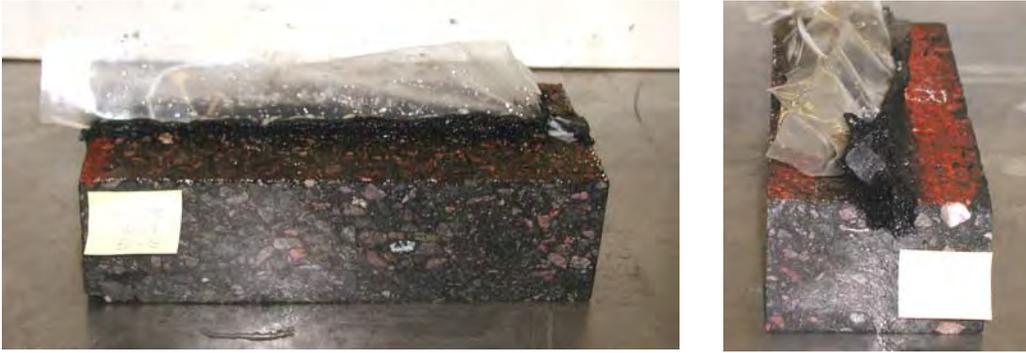
Figure 11. Sealant Bonded in Saw-Cut Reservoir After 8000 Cycles in the Asphalt Pavement Analyzer

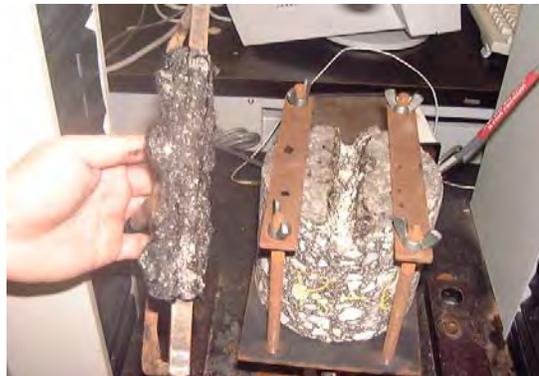
Figure 12 and 13 show samples after wet testing with routed and saw-cut reservoirs, respectively. The sealant in the wet test, routed sample (Figure 12) failed in adhesion to the asphalt concrete. Particles of shattered aggregate adhered to the sealant and gave the bottom of the sealant a sandpaper like texture. The sealant in a saw-cut sample (Figure 13) failed in the wet test in both adhesion and cohesion but there was still some sealant adhering to the asphalt concrete. Figure 14 shows a cohesion failure of the sealant in the dry pull-out test with a saw-cut reservoir.

Figure 12. Adhesion Failure of Sealant in a Wet, Pull-out Test with a Routed Reservoir

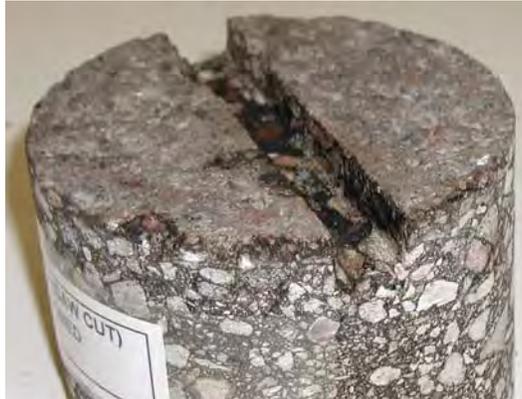
Figure 13. Partial Adhesion and Partial Cohesion Sealant Failure in a Wet, Pull-out Test with a Saw-Cut Reservoir

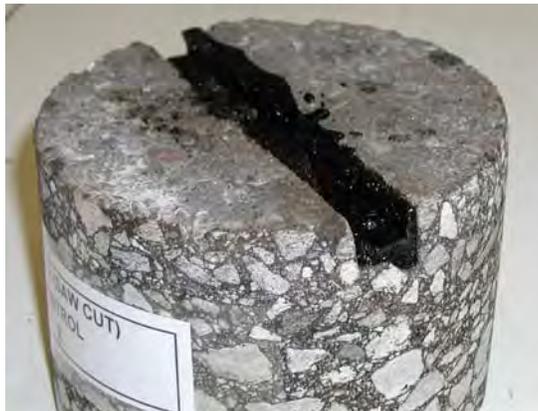
Figure 14. Cohesion Failure of Sealant in a Dry, Pull-out Test with a Saw-Cut Reservoir

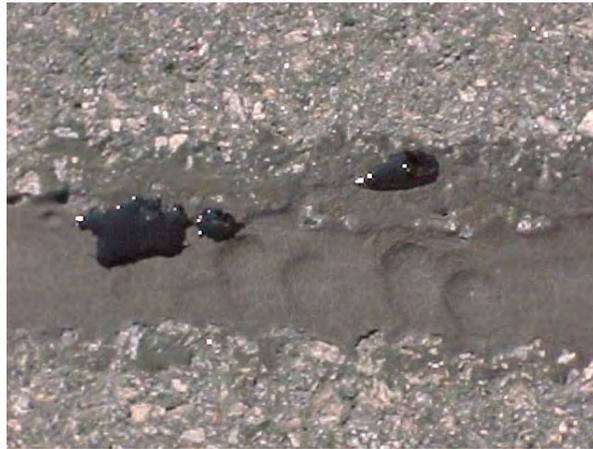
Typically, the sealant was only bonded to the adjacent pavement at the top 2 to 3 mm of the rout and could be easily pulled from the rout. When the sealant was removed from the rout, the underlying pavement was observed to be damp to wet (except at the west end of the runway where the sealant was found to be well adhered and the rout was dry). The pavement surface adjacent to cracks was observed to be sound. The sealant had numerous blisters up to about 50 mm in diameter. When intact blisters were pressed down, water was often forced to the pavement surface at the edge of the seal, as shown in Figure 15. When blisters were opened up, free water was also often observed.

Figure 15. Water Forced out of a Sealed Transverse Crack on Runway 08-26 at Canadian Forces Base Goose Bay

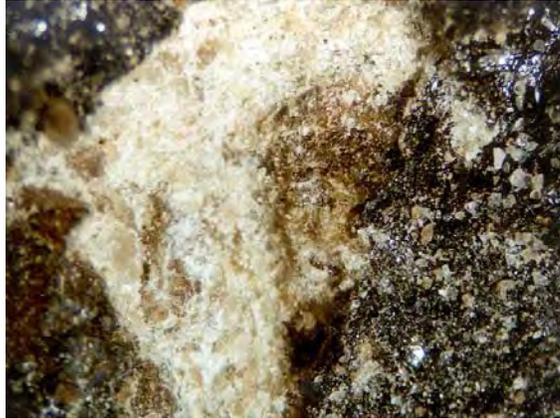
The majority of coarse aggregate particles in the vertical faces and bottom of the rout were observed to be shattered at the rout/sealant interface. Figure 16 shows a microscopic photograph of a sample from the Highway 401 project highlighting the typical shattering of a coarse aggregate particle at the bottom of the rout. The red meta-arkose/granitic aggregate is known to be very hard/brittle and it is likely that the shattering occurred as the result of the routing operation. No shattering of the coarse aggregate was observed where the pavement slabs were saw-cut. This suggests that the saw-cutting operation causes significantly less damage to the hard/brittle meta-arkose/granitic coarse aggregate than the impact routing operation.

Field observations and laboratory testing confirm that the loss of sealant appears to be mainly the result of the impact damage to the brittle red meta-arkose/granitic coarse aggregate caused by the routing equipment shown in Figure 17. In order to mitigate potential shattering of such aggregates during routing, the use of a random-crack saw with diamond blades, as indicated in (Figure 18 should be considered for cutting the crack sealant reservoirs in asphalt pavements containing brittle aggregates. This equipment/method will cause less damage (particularly aggregate shattering) to the pavement than conventional routers.

Figure 16. Microscope Photograph of Shattered Aggregate at the Bottom of the Rout in a Slab Cut from Highway 401 Westbound in Mississauga.

The 40 by 10 mm rout configuration and application of a hot-poured sealant is the most commonly used method of crack treatment in Ontario. Unfortunately, this method is not always cost effective and in some cases the routing can cause severe damage to the asphalt concrete. As such, crack filling, without routing, should be considered for non-working cracks (movements less than 2.5 mm) particularly in pavements incorporating hard brittle aggregates. Non-working cracks typically include diagonal cracks, most longitudinal cracks, and some block cracks. Non-working cracks having moderate to no edge deterioration should be filled regularly to reduce the infiltration of water. Crack filling is considered to be a cost effective and quick operation. As no routing is performed, the crack filling will not cause any damage to the pavement. Crack filling should be done early in the life of the pavement, before the crack has the time to deteriorate to the extent that sealing (with routing) or repair is required. Harder, more resilient, low viscosity sealants are recommended for the crack filling operation. Only working cracks (movement greater or equal 2.5 mm) should be routed and sealed, but the procedure used should consider the damage that the routing operation can cause. For pavements incorporating hard, brittle aggregates saw-cutting is the preferred method to develop the sealant reservoir.
