**12-Year Performance Review of Bloomington Road (York Region Road 40)
Rehabilitation using Cold In-Place Recycling and a 6.7 mm Fine Stone Mastic
Asphalt**

240 12-YEAR PERFORMANCE REVIEW OF BLOOMINGTON ROAD REHABILITATION

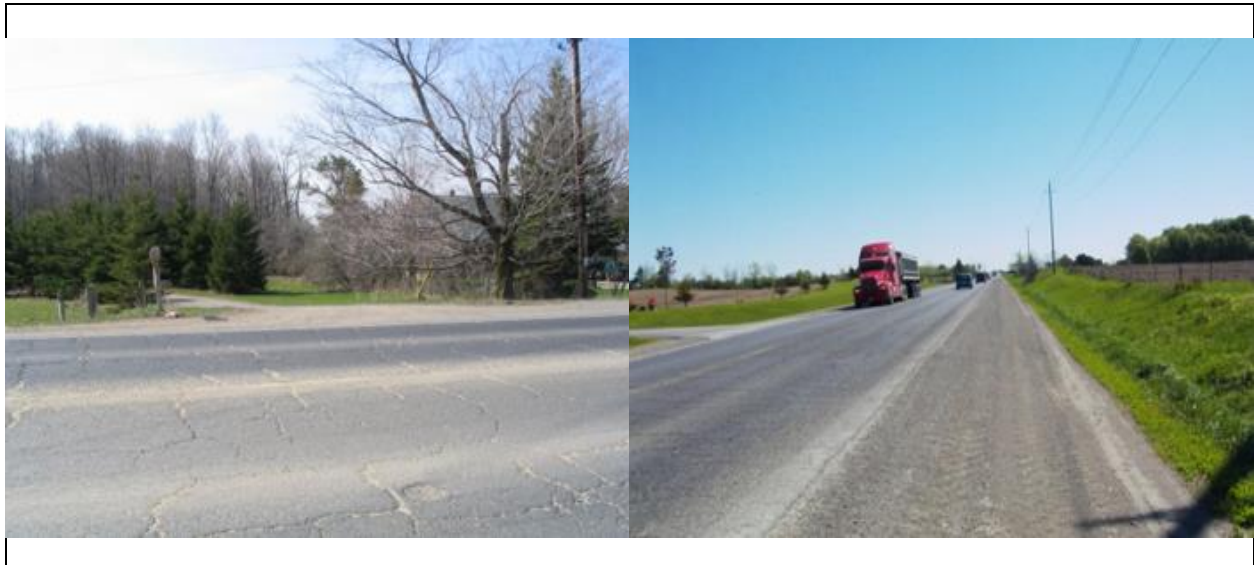
The pavement condition survey summary performed by the consultant indicated varying densities and severities of map, longitudinal, transverse, edge, construction joint, and alligator cracking, which resulted in an overall pavement condition rating of Poor. Analysis of the surface HMA indicated the presence of slag aggregate, which explained the map cracking observed. In addition to the road surface rating, shoulders were mainly classified as good, with some sections rated as fair, and the ditches rated as fair, where cleanout was suggested. Figure 1 illustrates the typical pavement and shoulder condition prior to recycling.

Figure 1. Typical Pavement and Shoulder Condition Prior to Recycling

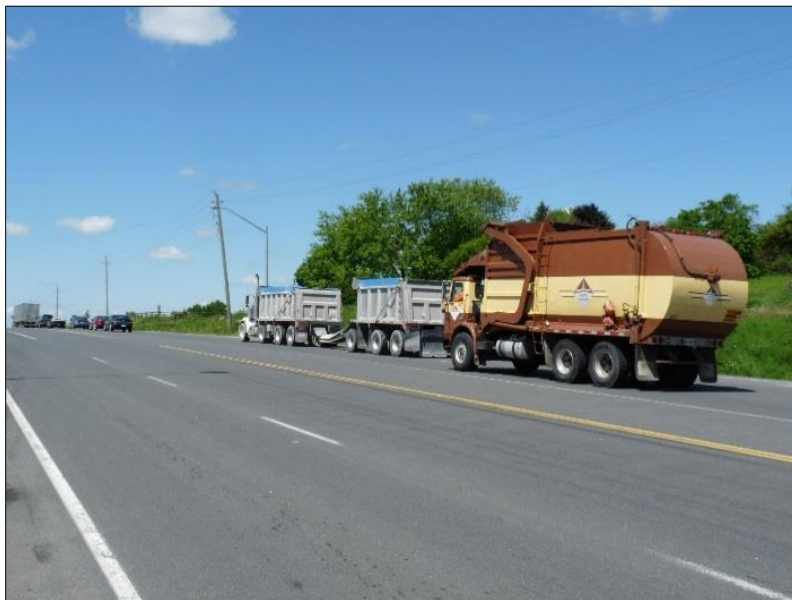
The pavement condition was conducted according to the Manual for Condition Rating of Flexible Pavements, SP-024 [8]. The survey indicated an excellent Pavement Condition Rating (PCR) of 95 and Ride Condition Rating (RCR) was assessed to be 9.5. From a visual perspective, there was no evidence of cracking within the traveled lanes, no coarse aggregate loss or raveling, no rippling or shoving, no distortion, and no rutting as exhibited in Figure 6.

Figure 6. Typical Four-Year Condition of Bloomington Road

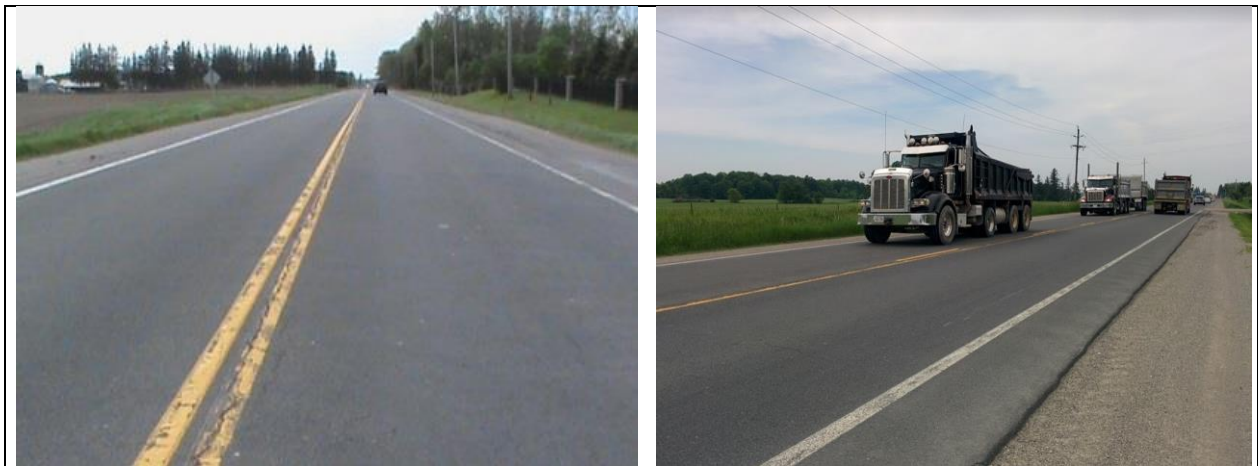
Based on the 2016 pavement survey data collection, the PCI for both road sections (Kennedy Road to McCowan Road and McCowan Road to Highway 48) are rated in Good condition. The observed pavement survey data indicated few low to moderate severity levels of longitudinal, transverse, and edge cracks and low severity levels of rutting as depicted in Figure 8. The results indicate the pavement treatment has been very effective as the roads are in good condition after 12-years of service.

Figure 8. Condition of Bloomington Road in April 2017

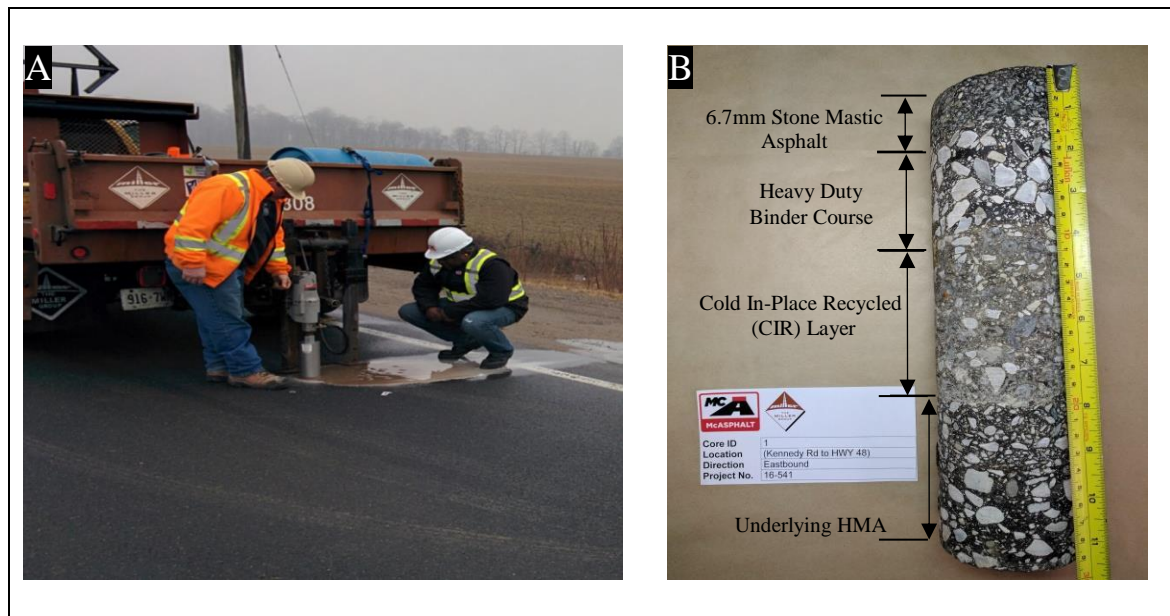
All cores were extracted from the pavement intact and all layers were well-bound. An example is shown in Figure 9. Asphalt layers were extracted with Trichloroethylene solvent and asphalt cement was recovered using the Abson recovery method. Extraction and recovery were performed in accordance with LS-282 and LS-284, respectively [10, 11].

Figure 9. (A) Coring Operation for a 12-year Old Section of Bloomington Road (Highway 40) in Ontario, Located Between Kennedy Road and Highway 48, and (B) A Well-bound Core Extracted From Bloomington Road

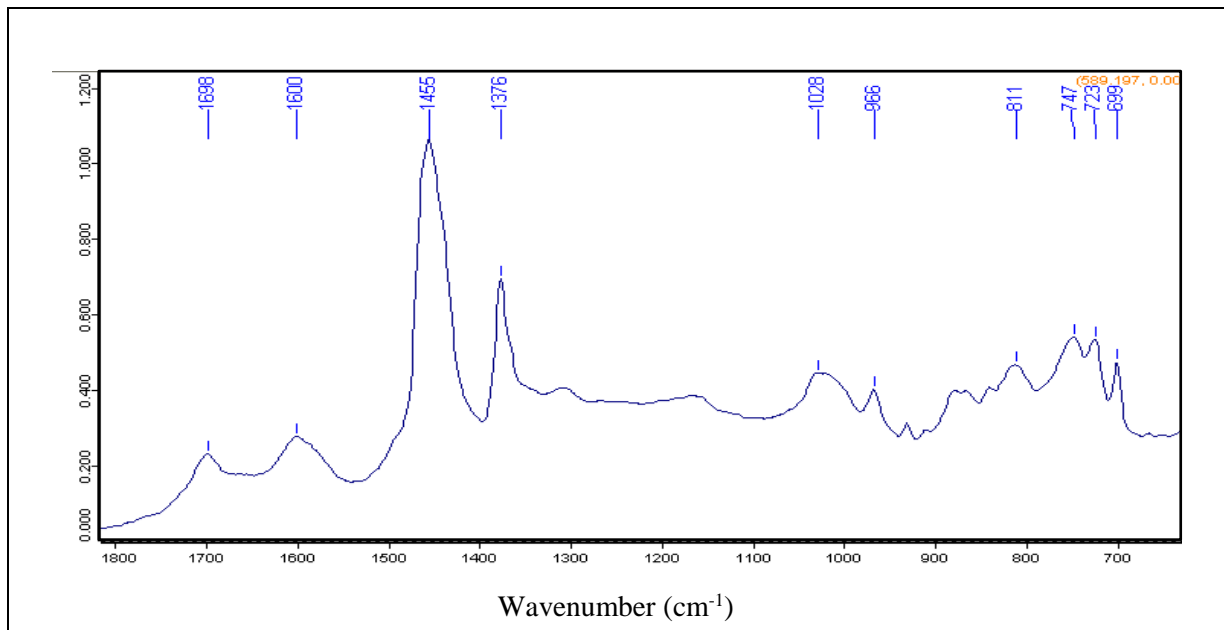
A Fourier Transform Infrared Spectroscopy (FTIR) analysis was conducted on the recovered binder to: (1) ensure that the solvent has been completely removed during the recovery, (2) evaluate the amount of polymer still present in the recovered binders, and (3) quantify the degree of aging of the recovered PG binder. Figure 10 shows an example of FTIR spectrum showing the absorbance peaks specific to carbonyl (1698 cm⁻¹), poly-styrene block (699 cm⁻¹), poly-butadiene block (966 cm⁻¹) and the reference peaks specific to the methyl groups (1455 and 1376 cm⁻¹).

**Figure 10. FTIR Spectrum of Modified Binder Recovered from SMA Surface Layer After 12-Years**

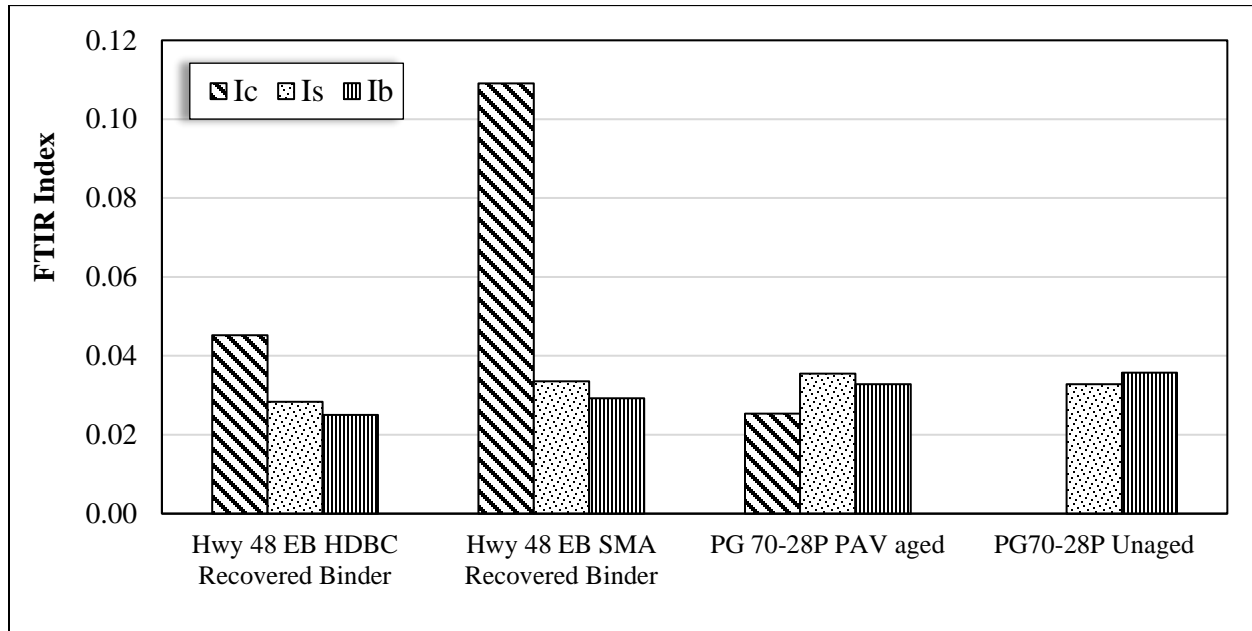
Butadiene and styrene segment indices listed in Table 11 and shown in Figure 11 indicate that field-aged binders recovered from SMA and HDBC retain approximately the same amount of SBS modifier as a PAV residue of the modified binder. Both PAV and field aging show a more pronounced drop in the butadiene segment compared to the styrene, as butadiene is the molecular species more susceptible to oxidation. The lower level of polymer presence in the HDBC recovered binder exists due to the dilution of the Polymer Modified Asphalt (PMA) with the RAP fraction binder.

Figure 11. FTIR Indices for Recovered Binders from Bloomington Road and Laboratory Aged

By contrast, the Carbonyl Index (I_c) shows that the field-aged binders have oxidized more than the laboratory sample after one PAV cycle, with the SMA binder being more aged than the HDBC. This is expected, as the SMA is subjected to UV exposure and to higher diffusion from the atmospheric oxygen. However, the field and the PAV aging mechanisms must be somewhat different, as the higher I_c of the field-aged samples do not correlate well with the SBS degradation rates or with the rheological properties measured. The PG and MSCR results of the field-aged samples are noticeably better than expected after an aging period that is more severe than a PAV cycle. Our belief is that the better than expected properties of the field aged asphalts could be related to the high Asphalt Film Thickness and VMA values for the SMA and HDBC mixes, as can be observed in Tables 2 and Table 3, respectively.

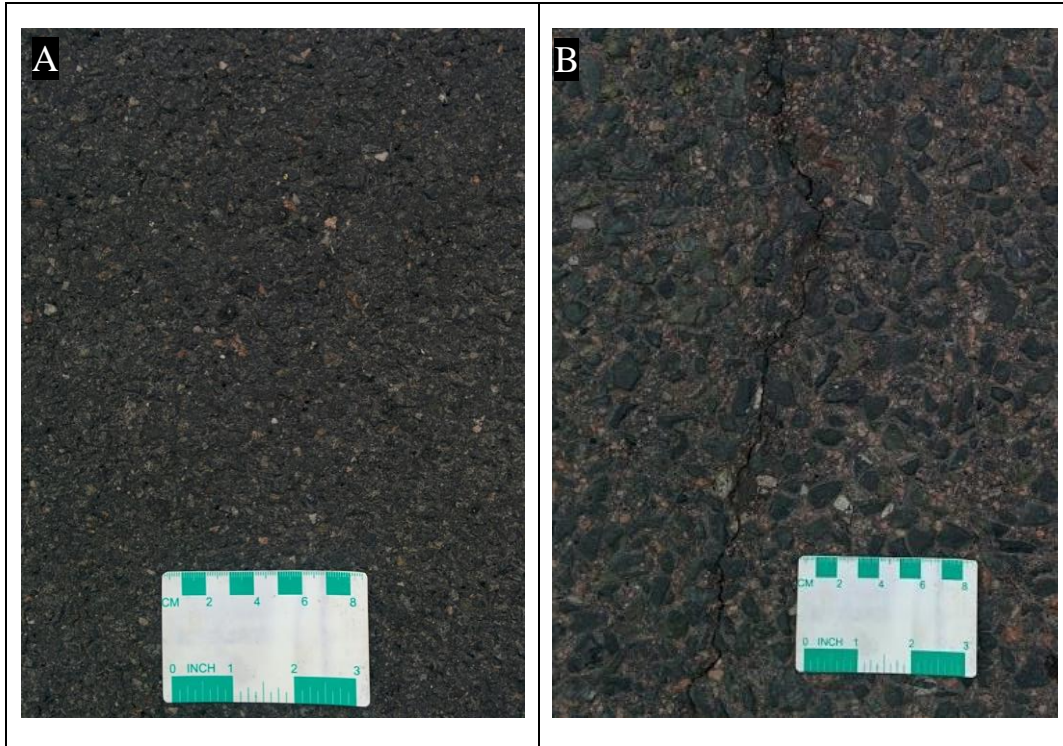
Higher film thickness was noticeable in the field, as the SMA still maintained a rich appearance as shown in Figure 12A with the aggregate well-coated even after 12-years compared to a picture of an adjacent Dense Graded Friction Course (DGFC) mix placed two-years previously (Figure 12B). The difference in coating and the aggregate size is evident by comparing the SMA and DGFC mixes.

Figure 12. (A) Rich Appearance of 6.7 mm SMA with the Aggregate Well Coated After 12-Years of Service and (B) Lean Appearance of DGFC Adjacent Pavement on Bloomington Road

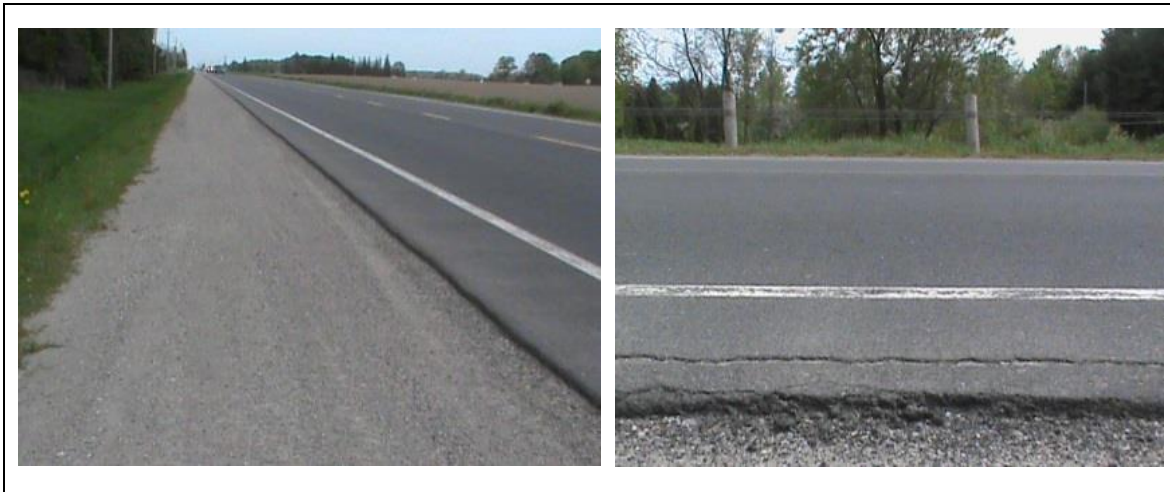
The Bloomington Road remains in good condition after 12-years of service, despite ongoing high volume of traffic. During the manual performance assessment, we observed isolated areas of shoulder pavement deterioration as shown in Figure 13.

The observed shoulder deterioration is due to heavy traffic by agricultural equipment from neighbouring farms and tractor trailers utilizing entrances along the length of the roadway. The strength of the shoulder directly impacts the long-term performance of the pavement edge and additional shoulder gravel may be required to increase shoulder elevation to ultimately offer additional support.

Figure 13. Typical Shoulder Condition of Bloomington Road

York Region has filled some of the cracks on Bloomington Road, including sealing of the centreline joint in 2009. Additional cracks have since surfaced that are very slight to slight in severity but will deteriorate further with weather and traffic. In order to preserve the asset, a preservation technique such as micro surfacing or chip seal would seal the minor cracks, prevent further oxidation, and prolong the pavement life. These preservation treatments have been successfully used in York Region for many years.

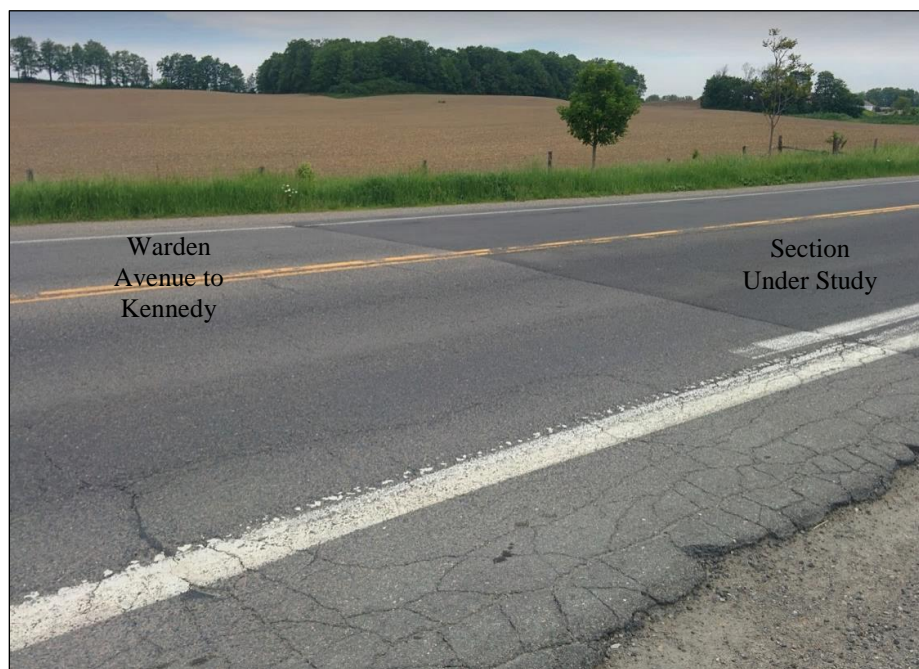
The section of Bloomington Road currently under study was compared to an adjacent section between Warden Avenue to Kennedy Road (Figure 14), with similar traffic volume and truck percentages. Stretching approximately two-kilometres, this road section was rehabilitated in 2003 by constructing 40 mm of DGFC and 50 mm of HDBC underlain by 100 mm of CIR.

Figure 14. Comparison of the study section to an adjacent section that exhibited more distresses for nearly the same service life.

The 2016 condition assessment results indicated poor road condition for this section, with moderate to high transverse cracking severity levels, low to moderate longitudinal, alligator, and edge cracking and rutting. Indeed, the Warden Avenue to Kennedy Road section has more observed pavement distresses with higher severity levels than the 6.7 mm SMA section, as depicted in Figure 14. It is specifically noted that the SMA section possesses higher rutting resistance than the adjacent section. Therefore, one may conclude that the adjacent treatment is not as effective as the treatment in this study despite the two years difference in lifespan.
