EVALUATION OF ASPHALT PAVEMENT CRACK SEALING

Kelly Carrick
McAsphalt Industries Limited
Toronto, Ontario

John Emery and Ludomir Uzarowski
John Emery Geotechnical Engineering Limited
Toronto, Ontario

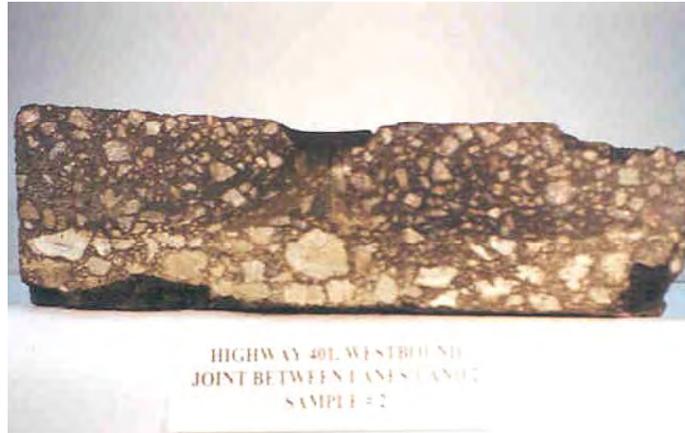
During the Highway 401 Westbound site inspection in Mississauga, four asphalt concrete slabs were dry cut from the asphalt pavement. The slabs were cut such that they straddled sealed cracks and a removed slab is shown in Figure 6. The rout was about 40 mm wide and 10 mm deep and no shattered particles were observed on the saw-cut vertical face of the slab. In the laboratory, each of the slabs was visually examined, photographed and logged. The hot-poured rubberized crack sealant was then pulled from the slabs manually to assess the bond between the sealant and asphalt concrete. The slabs were then separated along the cracks and both the vertical crack face and the rout were examined. The exposed aggregate in the slabs was examined petrographically. The slabs were also examined under a binocular microscope to

Figure 6. Cross Section of a Slab taken from Highway 401 Westbound in Mississauga

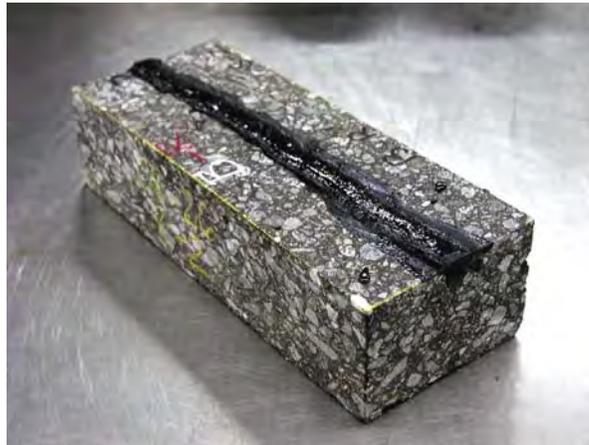
Figure 8. Sample with Routed Reservoir Filled with Crack Sealing

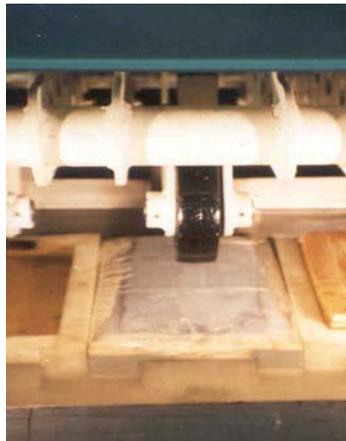
Figure 9. Crack Sealed Sample Ready for Wet Testing in the Asphalt Pavement Analyzer

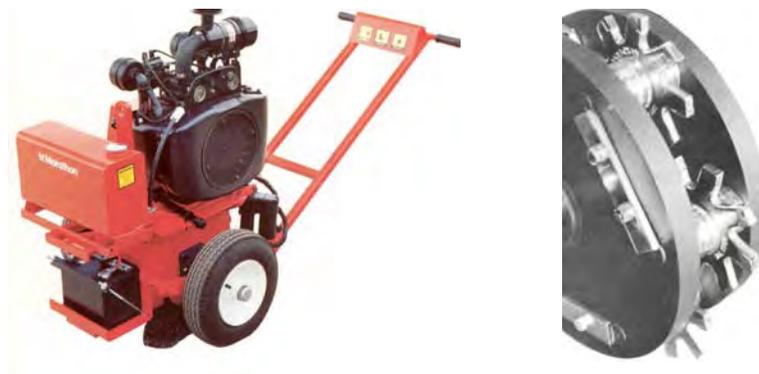
Field observations and laboratory testing confirm that the loss of sealant appears to be mainly the result of the impact damage to the brittle red meta-arkose/granitic coarse aggregate caused by the routing equipment shown in Figure 17. In order to mitigate potential shattering of such aggregates during routing, the use of a random-crack saw with diamond blades, as indicated in (Figure 18 should be considered for cutting the crack sealant reservoirs in asphalt pavements containing brittle aggregates. This equipment/method will cause less damage (particularly aggregate shattering) to the pavement than conventional routers.

Figure 17. Typical Pavement Crack Router and Router Blade

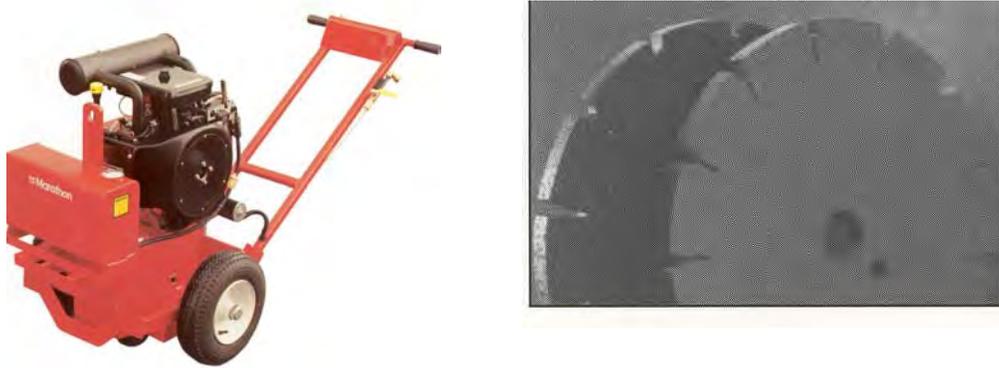
Figure 18. Typical Pavement Crack Saw and Saw Blades

A National Research Council (NRC) study completed in Canada [1] indicates that crack routing, cleaning and heating operations create defects in the surface course asphalt concrete, which in turn weaken the asphalt concrete-sealant interface. Routing can cause micro-cracking of asphalt concrete. The bond between the asphalt concrete and the sealant subsequently fails when the sealant pulls out the fines and shattered aggregate out of the asphalt concrete. This is exacerbated by moisture/water that penetrated into the shattered zone. The rotary-impact routers commonly used in Ontario can cause considerable damage to the asphalt concrete. Eaton and Ashcraft [2] confirmed that routing of any configuration is detrimental to pavements, and can even cause the surrounding pavement to crack. It is obvious that the damage can be much more severe if the asphalt concrete mix incorporates brittle aggregates (the red meta-arkose/granitic aggregates are considered to be very hard and brittle). The Federal Highway Administration (FHWA) [12] recommends the use of a random-crack saw with diamond blades, which causes less damage to the asphalt concrete and provides a more rectangular reservoir with smoother walls.
