**12-Year Performance Review of Bloomington Road (York Region Road 40)
Rehabilitation using Cold In-Place Recycling and a 6.7 mm Fine Stone Mastic
Asphalt**

240 12-YEAR PERFORMANCE REVIEW OF BLOOMINGTON ROAD REHABILITATION

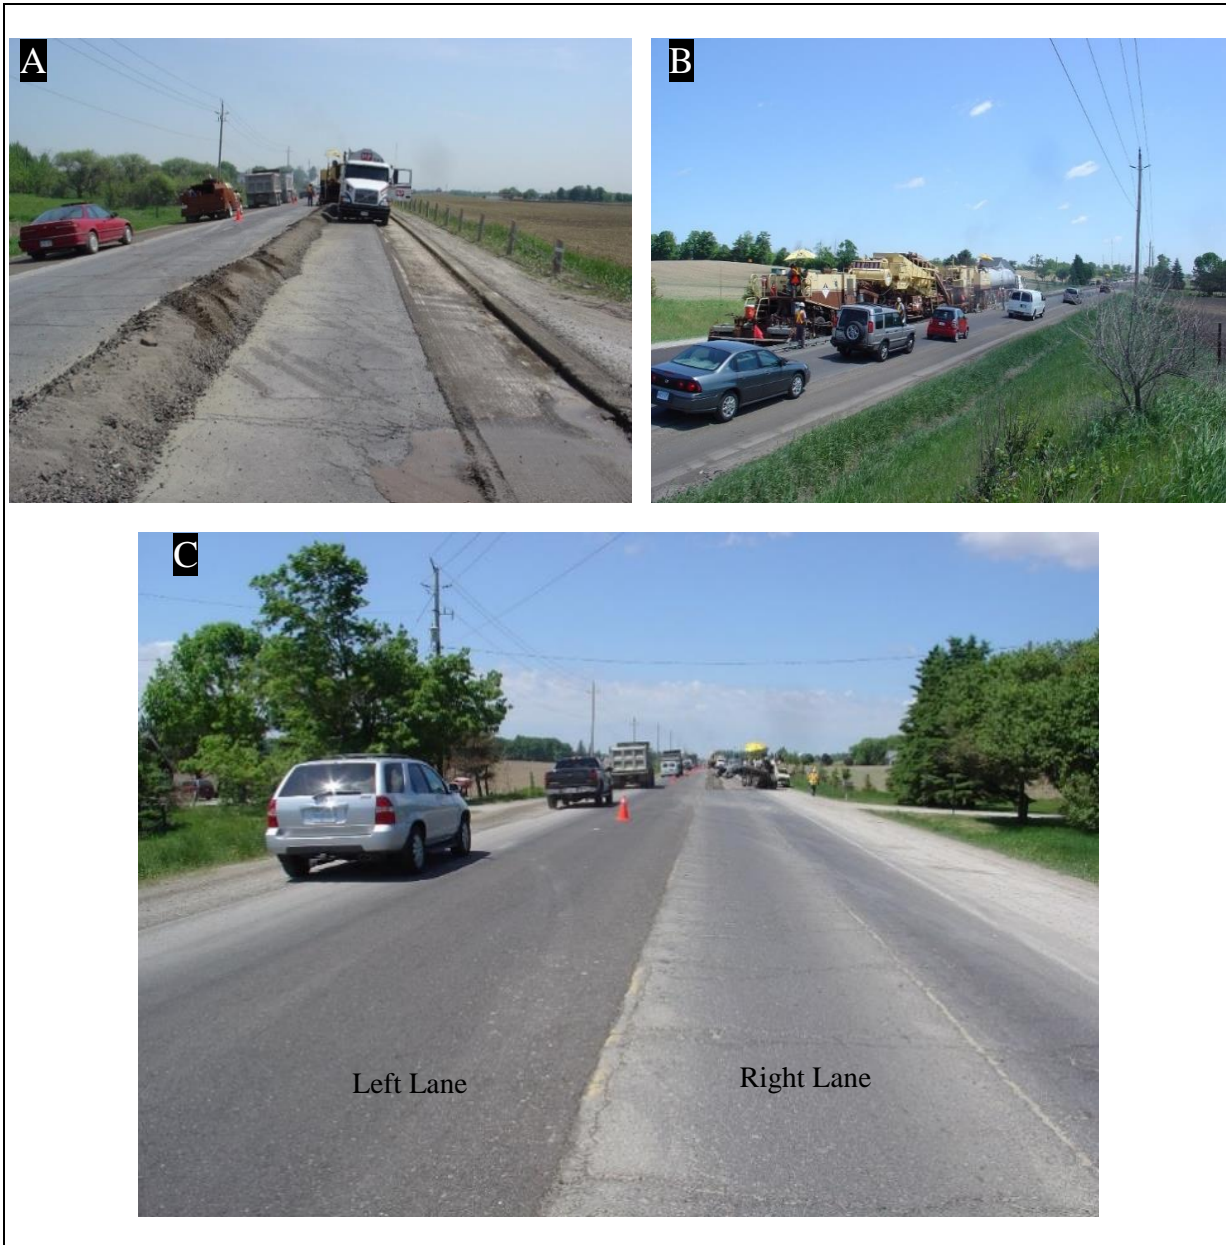
Figure 4. (A) A Section Milled by Small Milling Machine and Resultant Windrow, (B) Illustration of Cold-In Place Recycling Train, and (C) Completed CIR mat prior to Hot Mix Asphalt Paving

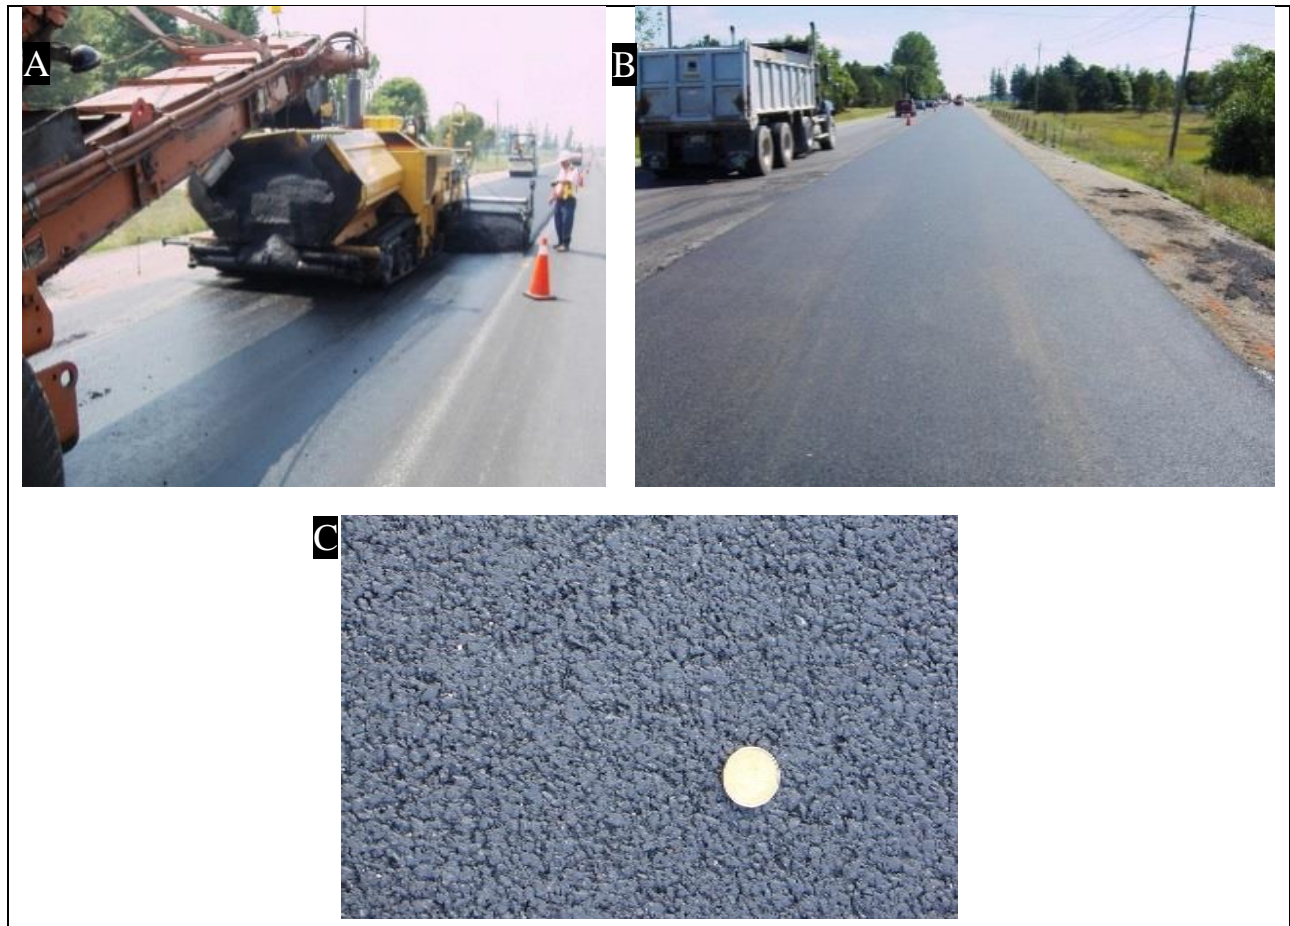
The HMA was constructed with conventional placement and paving equipment with the addition of a shuttle buggy. The construction equipment and typical surface of the 6.7 mm SMA mix is illustrated in Figure 5. The initial texture of the SMA surface appears open in nature and rich due to the relatively high binder content, which is common for these mixes. The stone-on-stone contact is evident due to the coarser aggregate fraction being more predominant in the mix.

Figure 5. (A) Equipment Used in Construction of Stone Mastic Asphalt, (B) Completed SMA Surface, and (C) Finished SMA Texture
